Cycling Accident Risks

Accidents involving cyclists

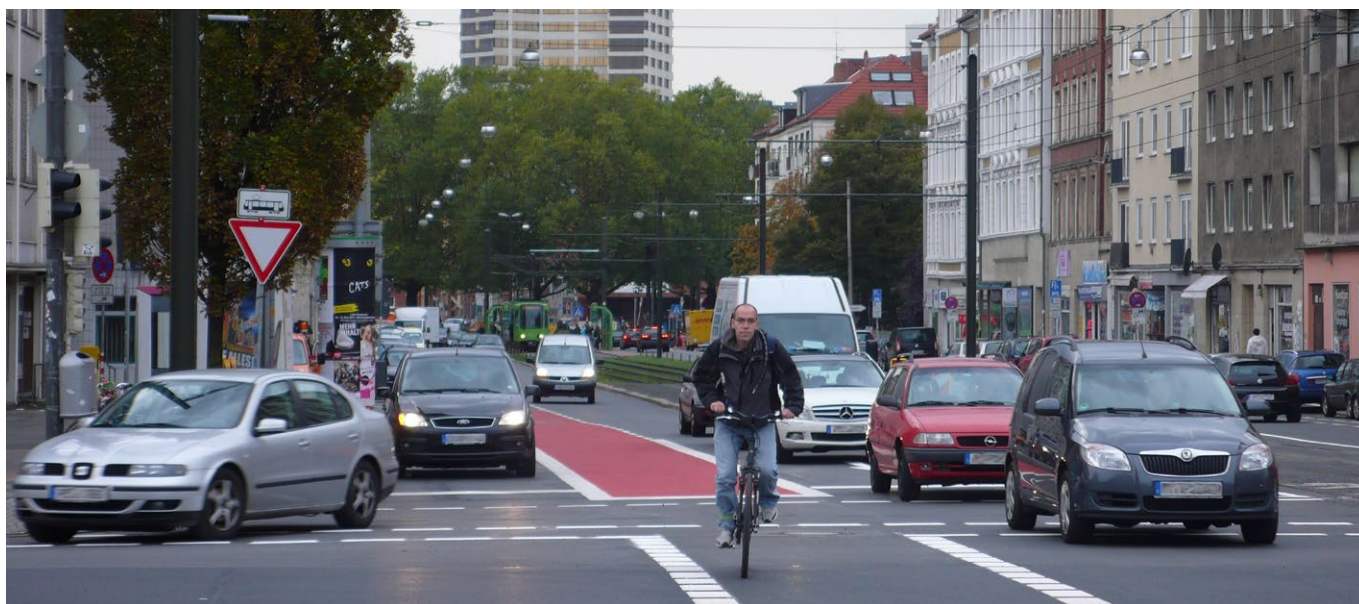
Safety by visibility – re-designed intersection in Hannover

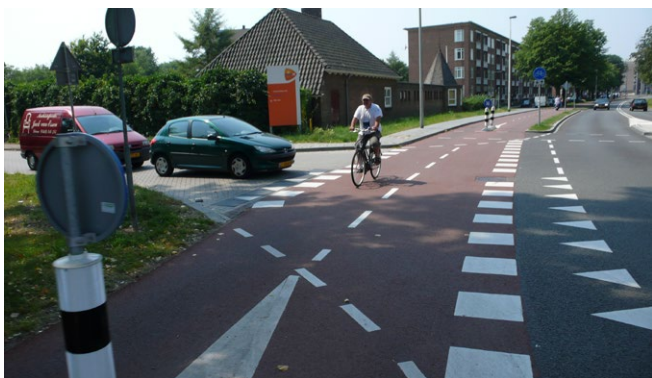
Safe crossing of a one side, two directions cycleway at side road (Arnhem, Netherlands)

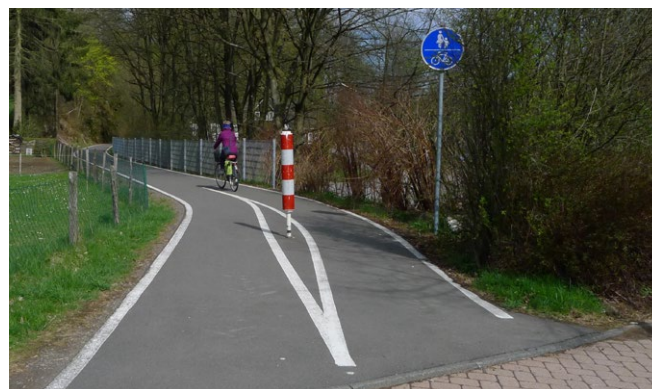
Visual contrast at bollard to prevent one-sided accidents (Cologne region)

Bollards that are to prevent cars from driving or parking on the pavement pose a significant risk because cyclists often do not see them, especially when they are in a group of cyclists. The Dutch cities of Zwolle and Amersfoort therefore have created websites where people can report bollards that are redundant (e.g. www.zwolle.nl/fietspalen). They received 3500 suggestions for the

removal and 500 for the relocation of bollards. Amersfoort took immediate response by taking 90 bollards off the cycle paths after winter road maintenance.

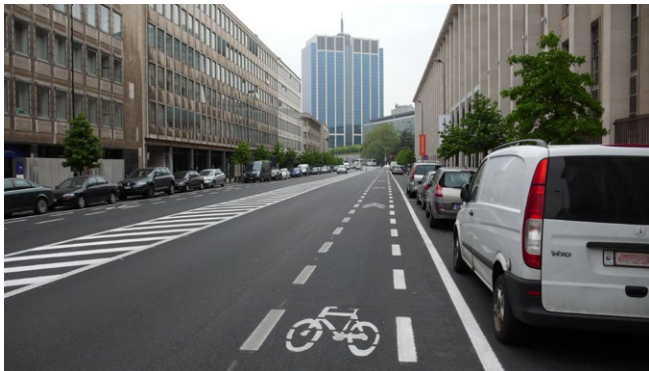
Brussels: Transformation of a four lane main street to a two lane street with cycle lane by new road markings

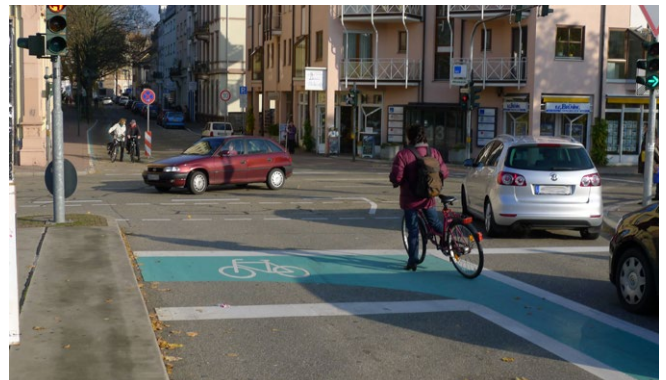
Bicycle box for safe turning left (Offenburg)
